## **GENERAL DESCRIPTION:**

The property inspected was a two-story, wood-framed building with brick veneer and vinyl siding. It was unoccupied during the inspection.

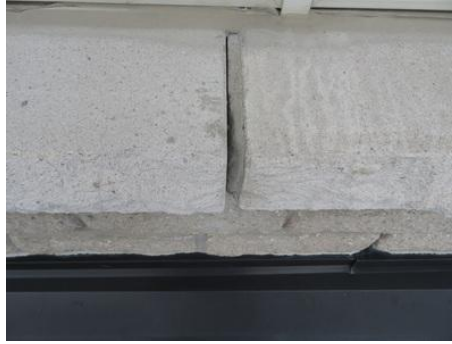
The brick mortar has cracked at the upper window area due to settlement. *It is recommended that it be repointed.*

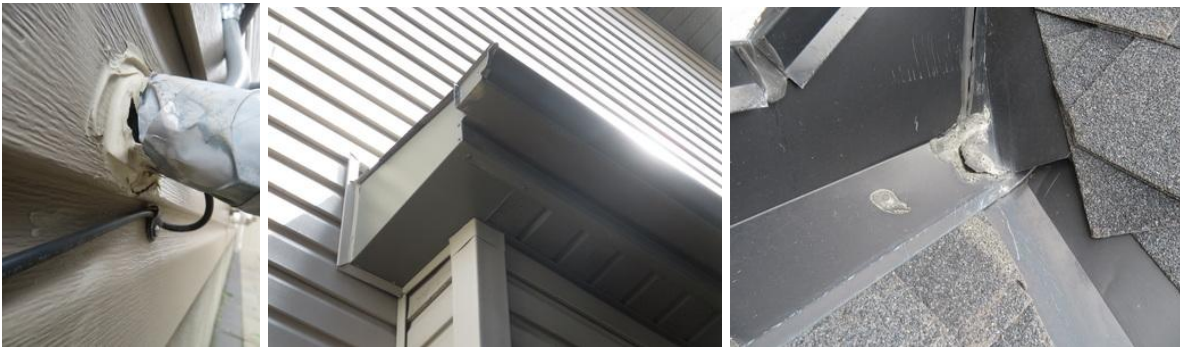
The exterior caulking is cracked and missing at the A/C line, the eaves trough on the right-hand side of the home, and the metal roof flashing at the front above the porch. *We recommend sealing these areas to prevent potential moisture problems in the future.*

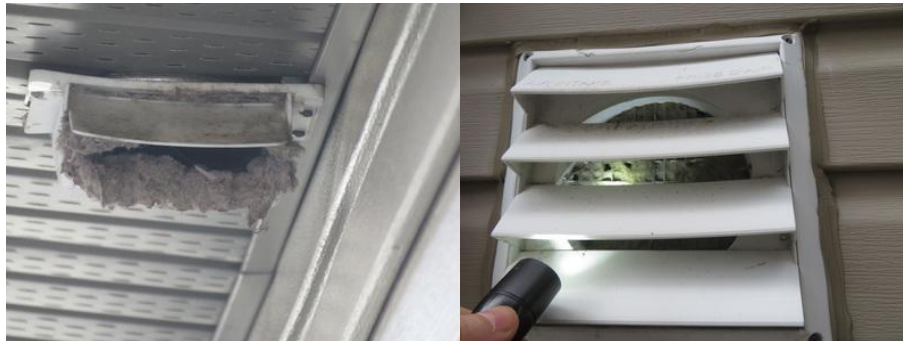
The dryer vent exhaust and the HRV intake are dirty and *require cleaning.*

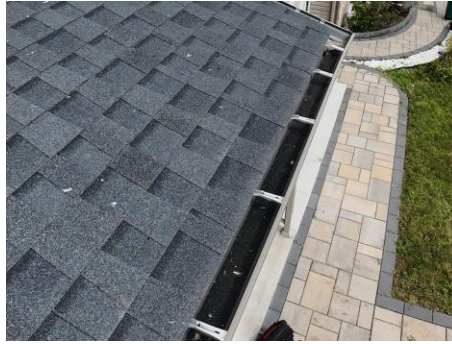
Debris is present within the eave area at the lower front section of the residence, which may necessitate cleaning. **It is advisable to have it cleaned.**

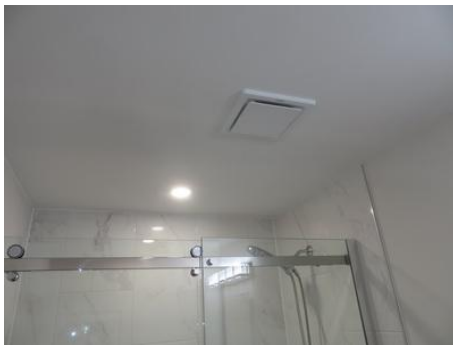
The absence of a supply air vent for the bathroom may result in a temperature discrepancy compared to the rest of the residence. **It is advisable to install a supply air register in the room.**

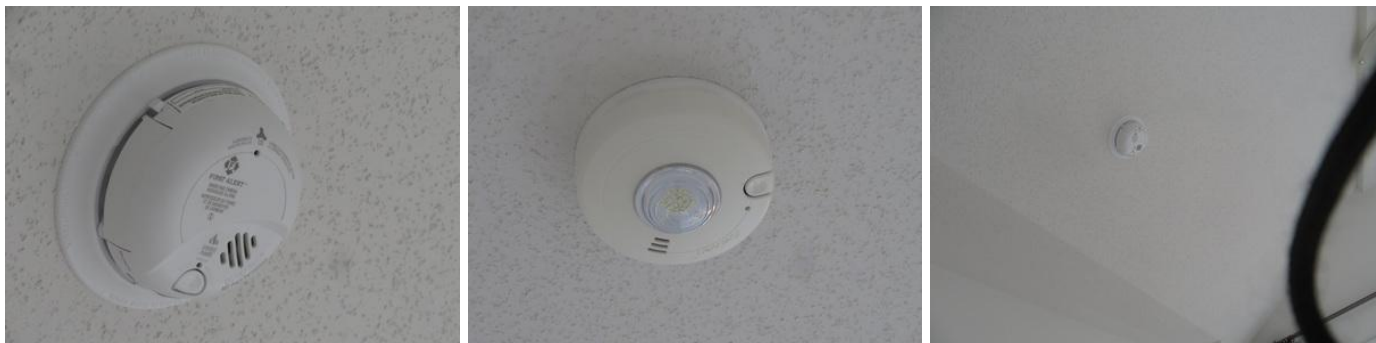
All smoke detectors are functioning throughout the residence, except for the one in the front bedroom which does not meet code. **Replacing this detector is recommended.**

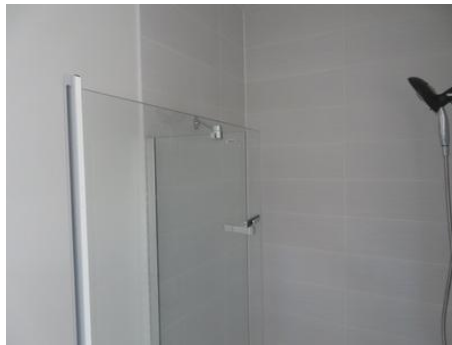
The ensuite shower door is insecurely fitted and not properly secured. This poses a risk of the shower door falling and breaking. **It is recommended that it be repaired promptly.**

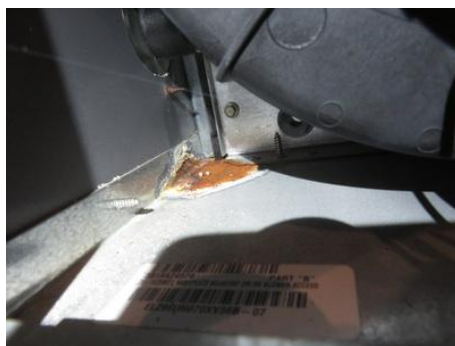
There is visible condensation previously leaked inside the furnace box, but it is not currently leaking as it has dried out. **Monitoring is recommended.**

**The estimated lifespan of gas furnaces is approximately 17 to 20 years. It is recommended that an inspection be conducted by a licensed gas technician prior to occupancy.**

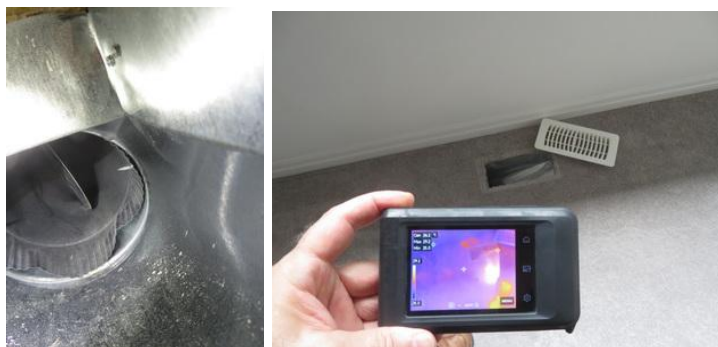
The air register situated in the bedroom on the middle left-hand side is not providing airflow to the room. In the absence of adequate ventilation, the temperature within this room may differ from that of the remaining areas of the residence. **It is advisable that this issue be addressed promptly.**

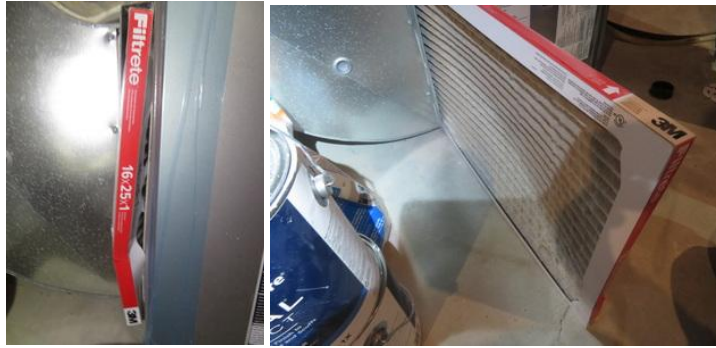
The furnace filter is significantly dirty and damaged, and **it is advised to have it replaced.**
