## GENERAL DESCRIPTION:

The property inspected was a two-story, wood-framed building with brick veneer and vinyl siding. It was occupied during the inspection.

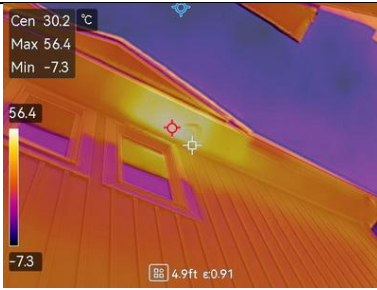
1. The dryer exhaust conduit is disconnected from the exhaust vent cover, as evidenced by thermal imaging. The heat source is located to the left of the vent cover.

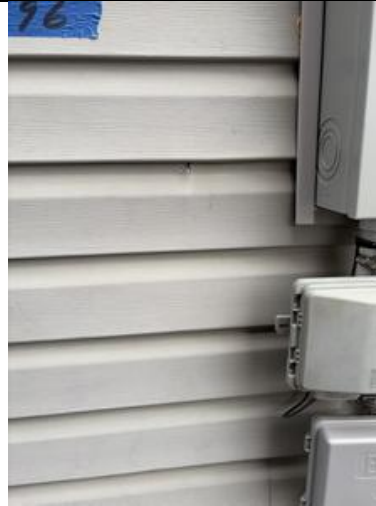
2. There is physical damage to the siding on the left-hand side of the residence adjacent to the hydro meter. The homeowner has not relocated any

items to the sides or the rear of the property.

2. There is physical damage to the siding on the left-hand side of the residence adjacent to the hydro meter. The homeowner has not relocated any items to the sides or the rear of the property.

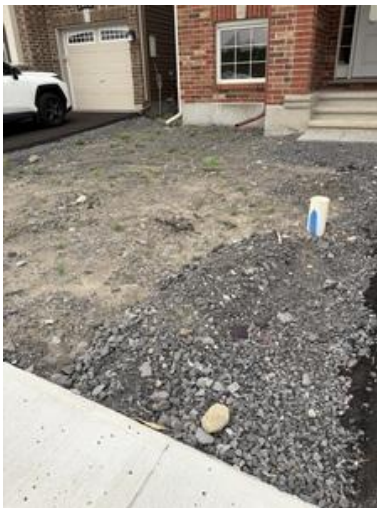
3. The landscaping at the front and rear of the home is incomplete.

3. The landscaping at the front and rear of the home is incomplete.
4. The metal fins around the A/C unit are dented. Repair is required for the A/C unit to operate efficiently.

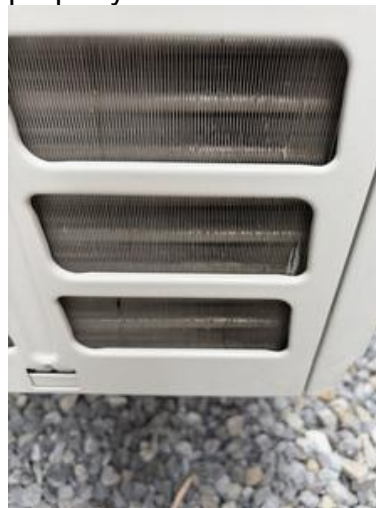
4. The metal fins around the A/C unit are dented. Repair is required for the A/C unit to operate efficiently.

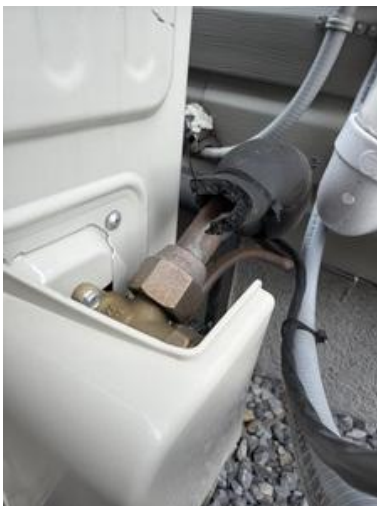
5. There are 3 inches of insulation missing around the exterior A/C refrigerant line.

5. There are 3 inches of insulation missing around the exterior A/C refrigerant line.
6. The weather stripping on the left side of the patio door lock has deteriorated.

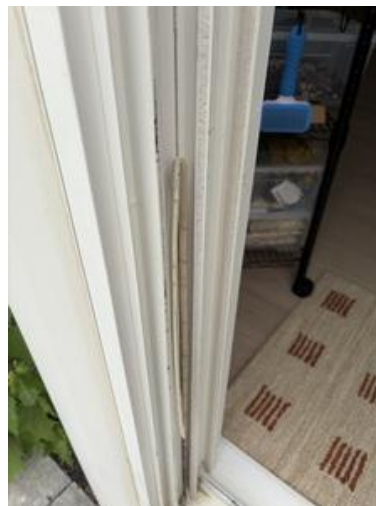
6. The weather stripping on the left side of the patio door lock has deteriorated.

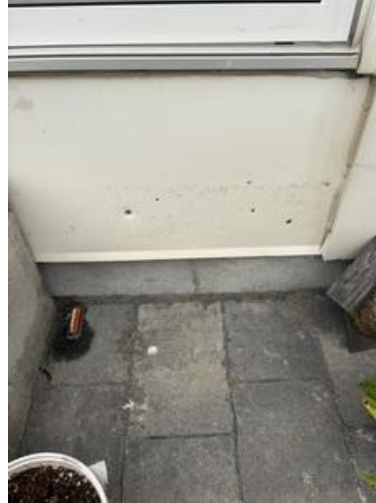
8. There are noticeable holes in the metal flashing beneath the patio door. It appears that a deck was previously attached to it, which has now been

removed. Repair is required.

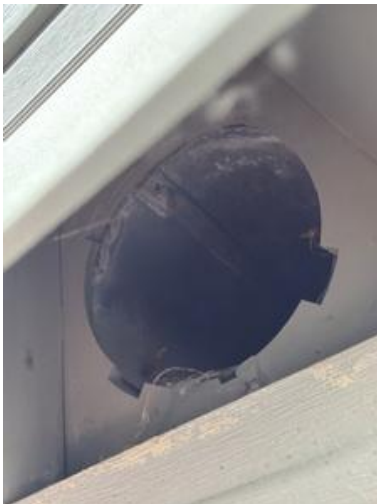
9. The exhaust on the left-hand side necessitates the installation of a damper or a mesh screen to prevent pests from entering the

residence.

9. The exhaust on the left-hand side necessitates the installation of a damper or a mesh screen to prevent pests from entering the residence.
10. The metal flashing on the second floor, situated on the right-hand side of the residence, is insecure due to its overhanging position.

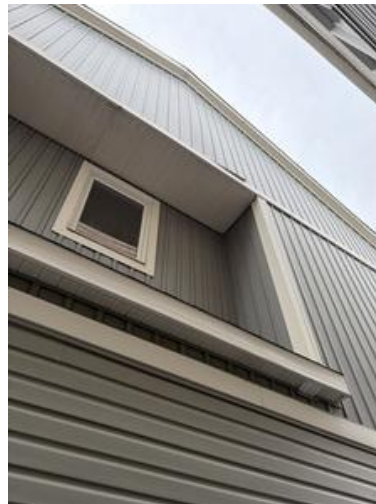
10. The metal flashing on the second floor, situated on the right-hand side of the residence, is insecure due to its overhanging position.

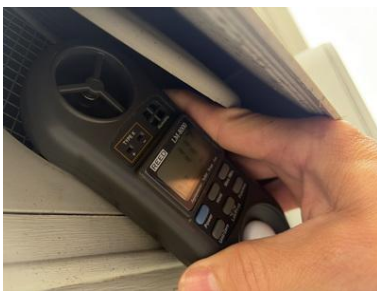
11. The air intake for the Heat Recovery Ventilation (HRV) unit is fitted with a

damper. The purpose of the damper is to prevent air from entering the HRV unit, which must be removed.

11. The air intake for the Heat Recovery Ventilation (HRV) unit is fitted with a damper. The purpose of the damper is to prevent air from entering the HRV unit, which must be removed.

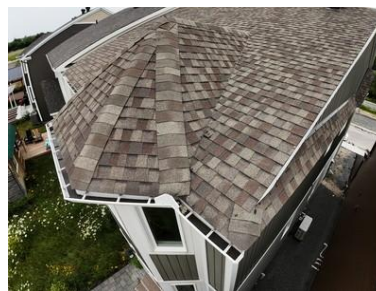
12. Both sides of the upper roof at the back of the home are missing 10 feet of valley

flashing.

12. Both sides of the upper roof at the back of the home are missing 10 feet of valley flashing.
13. There is an absence of caulking between the shower wall tiles and the shower base in the ensuite.

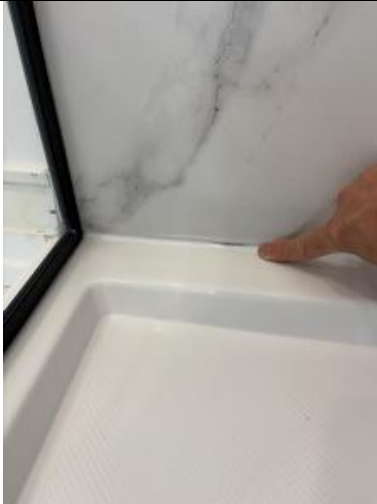
13. There is an absence of caulking between the shower wall tiles and the shower base in the ensuite.

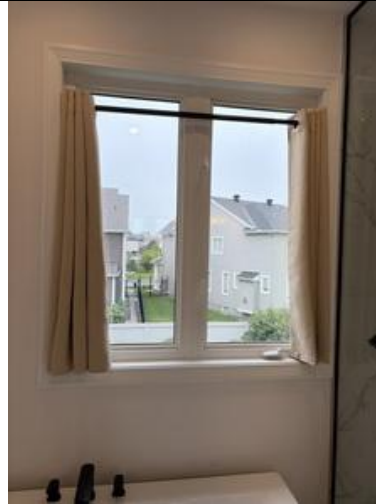
14. The window screen is absent in the ensuite.

14. The window screen is absent in the ensuite.
15. The powder room's exhaust fan is rated for 100 cfm but struggles to support even a piece of toilet paper. There might be a blockage or the fan could be defective.

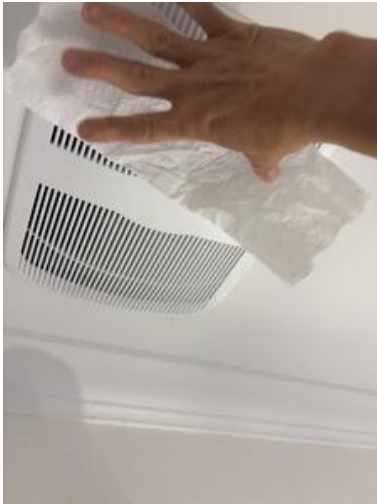
15. The powder room's exhaust fan is rated for 100 cfm but struggles to support even a piece of toilet paper. There might be a blockage or

the fan could be defective.

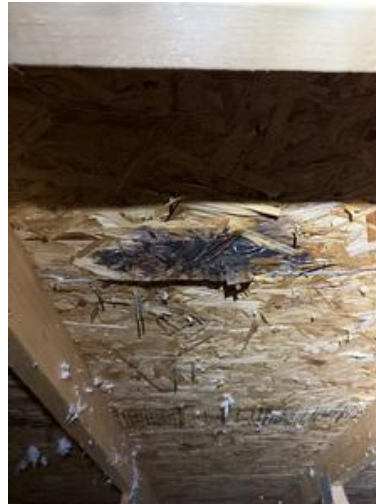
16. Visible mould is present in the attic beneath the area where the metal valley has not been installed.

16. Visible mould is present in the attic beneath the area where the metal valley has not been installed.
17. The cold air return fails to facilitate air suction in the bedroom located at the middle right-hand side.

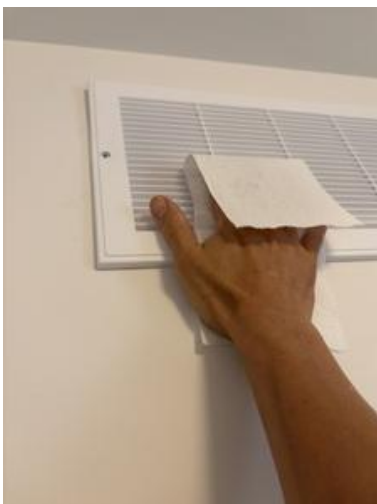
17. The cold air return fails to facilitate air suction in the bedroom located at the middle right-hand side.

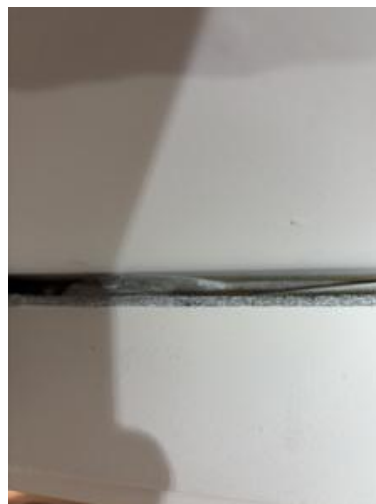
18. The excessive poly surrounding the attic hatch necessitates trimming to ensure proper closure of the hatch.

18. The excessive poly surrounding the attic hatch necessitates trimming to ensure proper closure of the hatch.
19. The insect screens are absent in the principal bedroom.

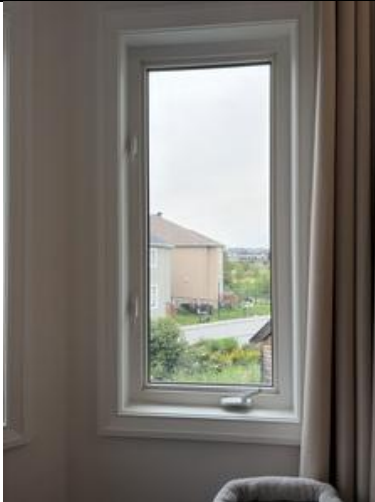
19. The insect screens are absent in the principal bedroom.

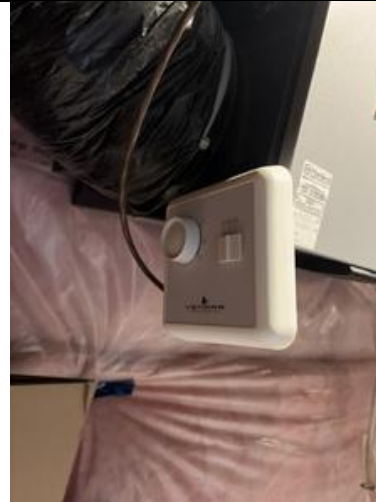
20. The HRV controller ought to be installed within the living area adjacent to the thermostat. Presently, it is positioned in the basement.

20. The HRV controller ought to be installed within the living area adjacent to the thermostat. Presently, it is positioned in the basement.
21. A workmanship defect has been identified on the hardwood transition strip between the primary bedroom and the hallway, resulting in movement and squeaking. Repair procedures necessitate the use of nailing and adhesive application, in accordance with the hardwood manufacturer's specifications.

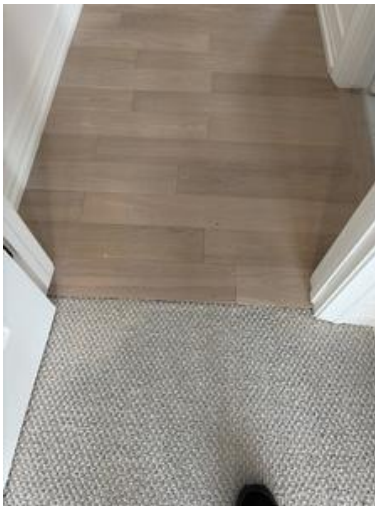
21. A workmanship defect has been identified on the hardwood transition strip between the primary bedroom and the hallway, resulting in

movement and squeaking. Repair procedures necessitate the use of nailing and adhesive application, in accordance with the hardwood manufacturer's specifications.

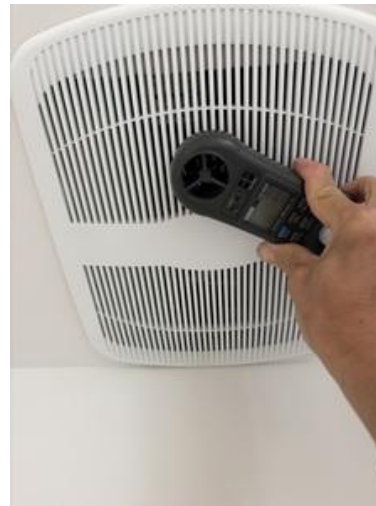
22. The en-suite exhaust fan does not provide any suction; furthermore, it appears that it does not terminate on the exterior side of the residence.

22. The en-suite exhaust fan does not provide any suction; furthermore, it appears that it does not terminate on the exterior side of the residence.
23. There is a water leak on the ceiling in the front right-hand side bedroom.

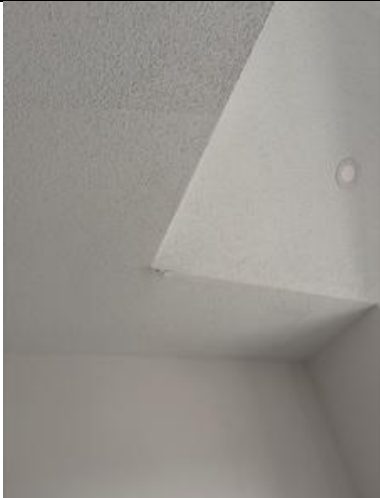
| | <p>23. There is a water leak on the ceiling in the front right-hand side bedroom.</p> | <p>24. The insulated blanket in the basement was cut open to perform an injection to the foundation and has not been resealed.</p> <p>25. The insulation in the attic has been compressed and walked on, and it requires replenishment. During the inspection, the inspector was walking on the trusses and bracing.</p> |
